Transport for London

Category A Station Audits

King's Cross and St. Pancras Stations

Final Report

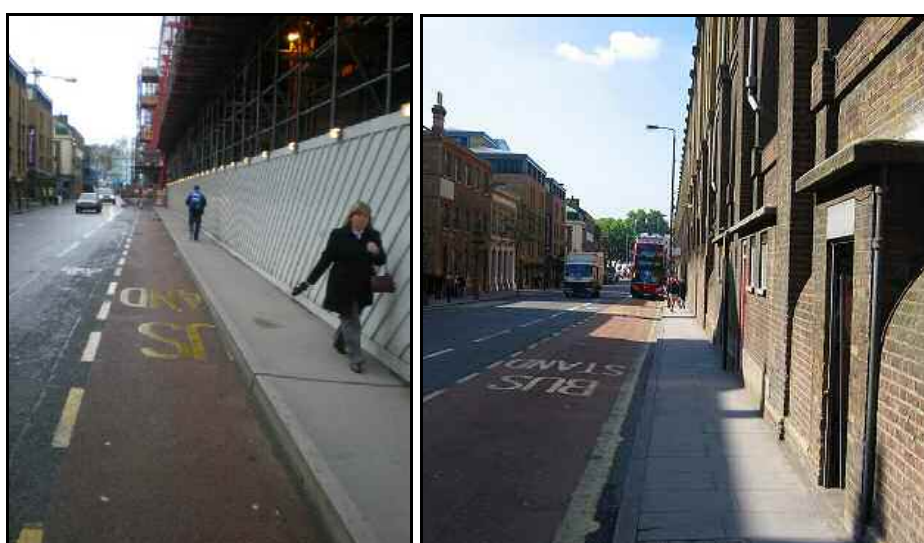
Plate 4.1: Long term works affecting L18/L20 (left) with narrow footpath even under normal conditions (right, picture taken in Summer 2007)

- **L18/L20** York Way from Wharfdale Rd to Pentonville Rd (westside) – These links run along the eastern wall of King's Cross Station and are increasingly being used because of the new commercial developments to the northeast of the station. The width is only sufficient for one person, and is not suitable for use by wheelchair users. The links face a one-way road, large sections of which are used by buses as a depot, and by taxis/private vehicles dropping off passengers. This results in large traffic noise, conflicting movements and reduced sightlines. Long term works on King's Cross Station further limit the width of the footpath as shown in Plate 4.1 below.

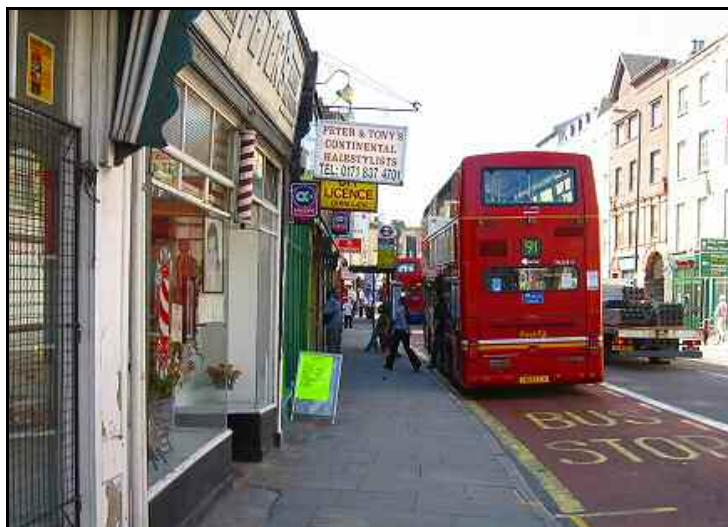
Plate 4.2: Shop signs and other street clutter on L19

- **L19** Caledonian Road (eastside) from Keystone Crescent (northside) to Pentonville Rd – This link is home to many restaurants and cafes, and is especially busy at lunchtime. Whilst pavement width is acceptable, the bus stops, shop furniture and goods create significant obstructions (see Plate 4.2) and cause conflicting movements. The link faces the busy Caledonian Road with its three lanes of traffic creating large amounts of pollution and noise.

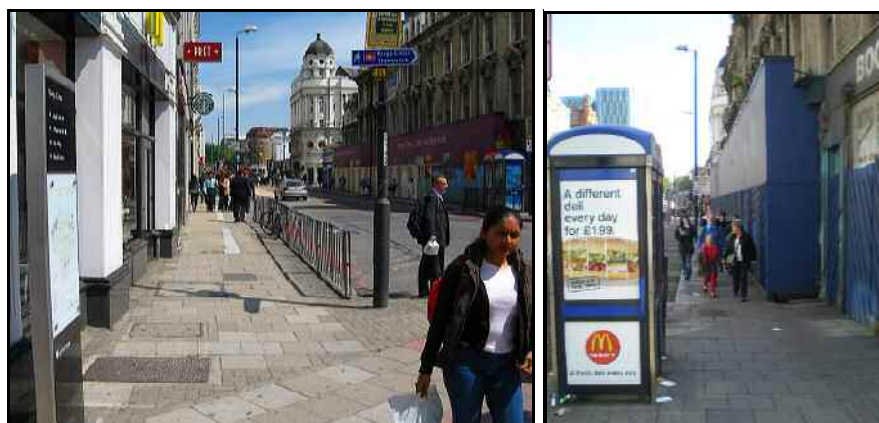
Plate 4.3: Inconsistent width on Pentonville Road (L5 left, L8 right)

- L5/L7/L8** Pentonville Rd (both sides) from King's Cross Rd to Gray's Inn Road – These links are found on either side of the busy Pentonville Road, with high volumes of speedy traffic causing large amounts of pollution and noise, and subtracting from the perception of road safety. The width of the footpath is inconsistent (as shown in Plate 4.3) and narrow at various locations, despite the large peak flows observed. Railings and A boards further limit the width at several locations. Some maps and signs in the area are outdated, and still show the relocated King's Cross Thameslink Station. Surface quality is acceptable along L8, but poor reinstatements and uneven surfaces are observed along most parts of L5 and L7.

Pentonville Road (northside) from York Way to Caledonian Road (L5)	
PERS Audit	CSA Audit
<p>Pedestrian flows on the link are relatively high, and the width of the footway does not always accommodate the pedestrian flows entirely although standards are met. Several obstructions cause pinch points, such as A boards being located in close proximity to permanent street furniture.</p> <p>Surface undulations are present, but as a whole the footway is generally level. Dropped kerbs are provided at crossing points, although not all are sufficiently flush to the carriageway. The crossing points are located at either end of the (short) link, but otherwise kerbs are high and may limit informal crossings. Tactile information is present at crossing points, although there are interruptions at Caledonian Road. Pedestrians with sensory impairments could potentially use the adjacent buildings as a tapping line, although A boards frequently interrupt. Very poor quality reinstatements affect the level of tonal contrast on the footway. Generally link surfaces are variable, with some areas of particularly poor quality surfacing.</p> <p>In terms of legibility, there is a signage board with a detailed map, and fingerposts on the link appear newly installed. Street activity on the link aid perceptions of personal security, and CCTV is present. Lighting is carriageway focussed and footway illumination after dark would rely on lighting from frontages. Frontages are of fair quality and maintenance, although on the opposite side of the carriageway frontages appear to be of poorer quality. Environmental quality is decreased by discarded litter, cigarette ends and chewing gum. High traffic noise also degrades environmental quality.</p>	<p>A quirk in the kerb line at the junction of York Way means that approximately 1 metre+ of nearside carriageway is very under utilised by cyclists. Auditors noted that many cyclists appear to cycle in the main carriageway, partly due to positioning and to the quality of the surface of the cycle lane. There would appear to be an opportunity to increase pavement width, which is much needed along the length of this link. It is important to assess the apparent under utilisation of the cycle lane and consider widening the pavement. If the cycle lane is necessary reallocate road space to pavement. The Islington map (outside McDonalds) still shows King's Cross Thameslink Station. The footway is obstructed by A boards. There is severe ponding on the carriageway near the Pentonville Road entrance to Regents Quarter. Throughout there is a lack of bike parking. There is no east west link into King's Cross from Regent Quarter (off York Way). The Islington map needs to be updated, the A boards removed, cycle parking is needed and the ponding needs to be addressed.</p>

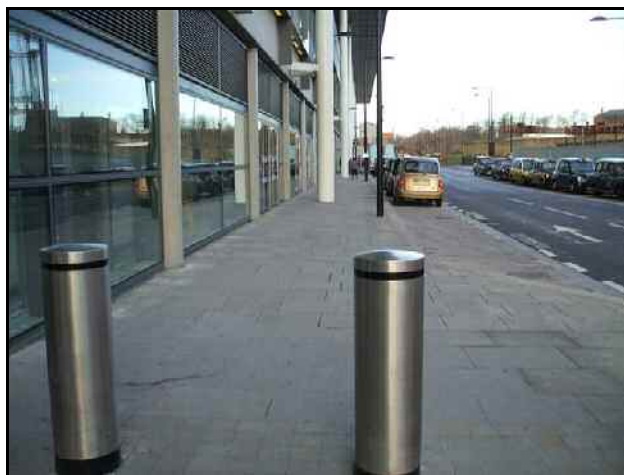
Plate 4.4: Steel bollards on L22

- L22** Pancras Road (westside) from St. Pancras central entrance to Goodway – This link is found along the eastern wall of St. Pancras Station. Permeability is poor due to the large traffic flows around the station entrance and shortage of controlled crossing points. The environmental quality is reduced towards Goodway, where neglected private frontages and commercial property are observed. Colour contrast is not used effectively to highlight the steel bollards around the station entrance area, tactiles and building pillars (see Plate 4.4).

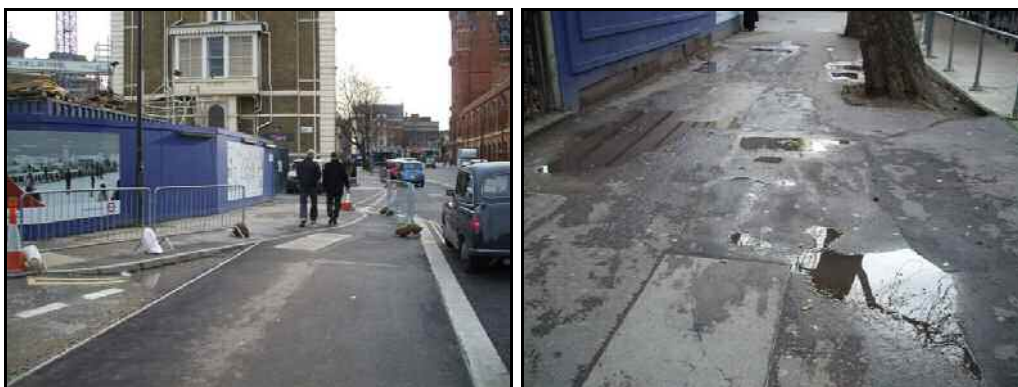
Plate 4.5: Temporary works and poor surface quality on L23

- **L23** Pancras Rd (eastside) from Euston Rd to Old Pancras Rd – The link is used by pedestrians traversing between the two stations, who may opt for the subway being constructed once it becomes operational. The link traverses an area which is currently being redeveloped; hence the effects of construction material and temporary works are strongly felt (see Plate 4.5). Permeability is low due to the scarcity of formal crossings, parked vehicles and the large level of taxi traffic. Surface quality decreases towards the south end, where obstructions such as trees, parked bicycles and poorly aligned sign/lighting posts also exist.

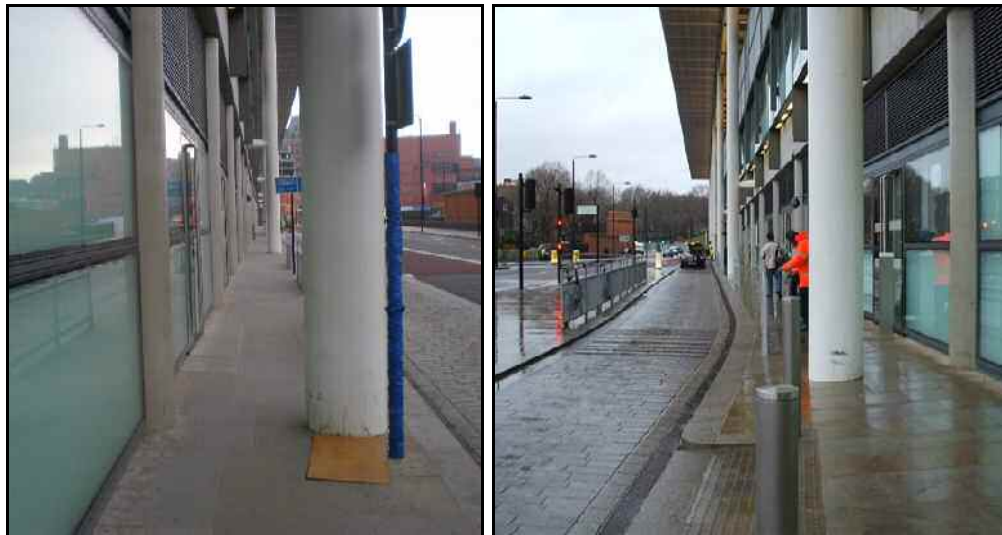
Plate 4.6: Pillars of St. Pancras Station narrowing footpath on L28

- **L28** Midland Rd (eastside) from Pancras Rd to St. Pancras westside entrance – This link is found on the western side of the newly refurbished St. Pancras Station and faces a taxi lane. The overhanging roof offers shelter from the weather, although leaking is also observed. Users suffer from the very narrow footpath and large pillars of the station building (see Plate 4.6). Although width increases towards the station entrance, dropped kerbs are not provided across the large vehicle entrance to the station. Kerbs are abnormally high, and create a large barrier for wheelchair users. Furthermore, signs are missing on the entire length of the link, making it difficult for pedestrians to find King's Cross Station and other nearby attractors.

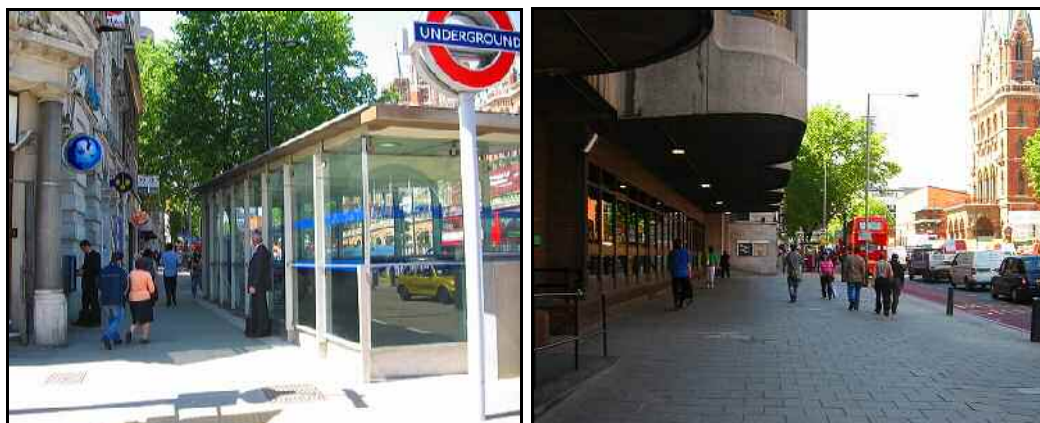
Plate 4.7: Underground entrance on L10 (left) and crossfall on L11 (right)

- **L10/L11** Euston Rd (southside) from Crestfield St to Judd St – The two links are situated directly south of St. Pancras Station, along the noisy and polluted Euston Road. Permeability is poor, owing to the 6 lanes of heavy two-way traffic and the central barriers. As shown in Plate 4.7 below, the underground entrance limits width on L10, which is exacerbated by the presence of a sign post. Crossfall and paving surface is poor along L11 (also shown in Plate 4.7), where a bus stop, kiosk and unnecessary street furniture (e.g. bollards and dysfunctional lighting columns) create obstructions.

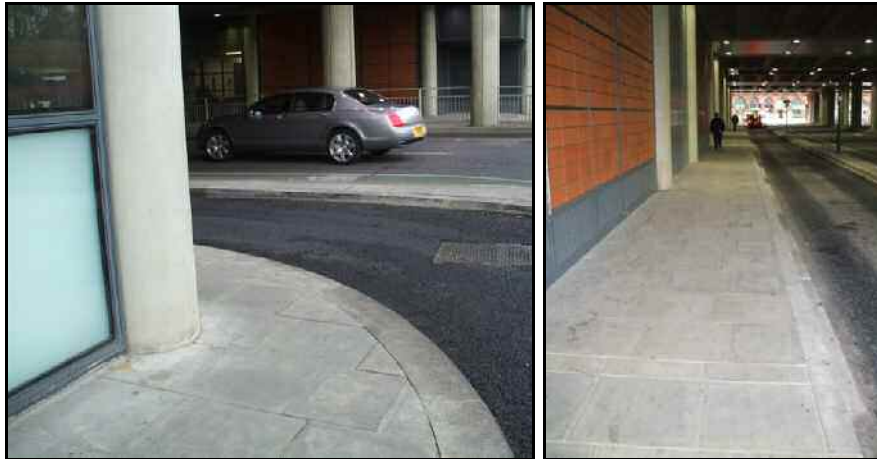
Plate 4.8: Lack of crossing points and narrow corners on L25 and L26

- **L25/L26** Goodway tunnel (both sides) from Pancras Rd to Midland Rd – This tunnel was perceived by Community Street auditors to be highly unattractive, despite the new build and acceptable lighting. Width is adequate, except for the area around the corners where wheelchair users may struggle to pass through. As illustrated in Plate 4.8, permeability is poor due to the lack of dropped kerbs, heavy traffic and a shortage of controlled crossings at either end where strong desire lines exist.

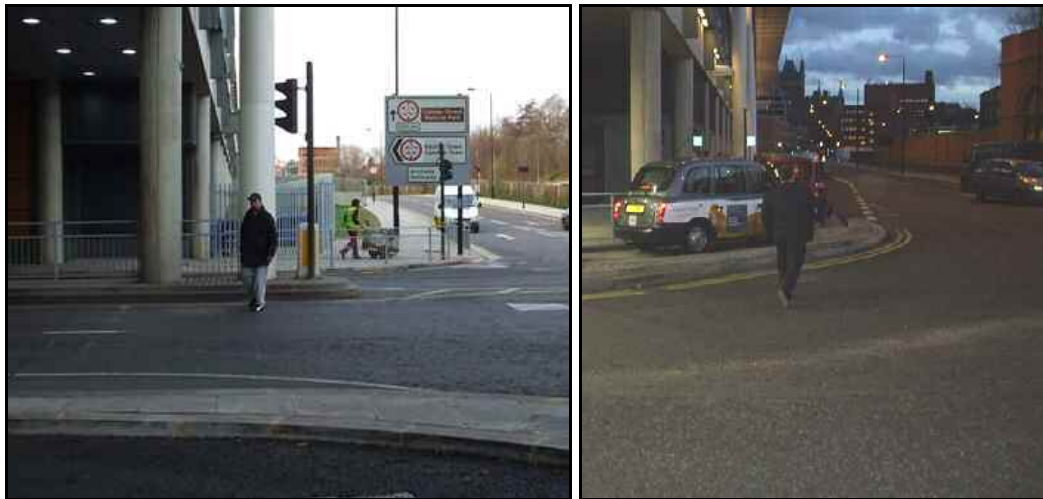
Plate 4.9: Lack of formal crossing provision at Goodway tunnel

- **C43/C45/C46** Informal crossings at both ends of Goodway tunnel – Both the PERS audit and CSA identified the lack of formal crossings on both ends of the newly-built tunnel to the north of St. Pancras Station (as shown in Plate 4.9). The presence of guardrails, heavy traffic (with a high proportion of taxis), and undropped kerbs make informal crossings very difficult and hazardous, particularly for mobility impaired users.

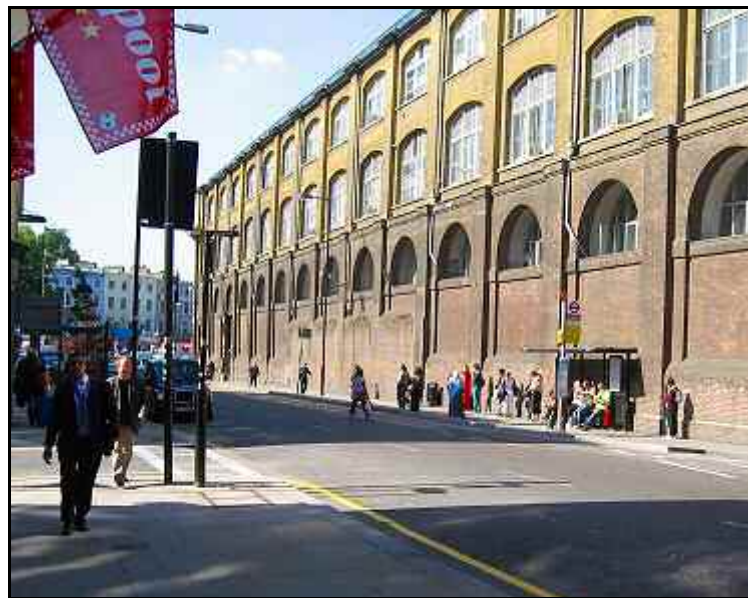
Plate 4.10: Informal crossing across York Way (C30)

- **C30** Informal across York Way south of Caledonia St – This informal crossing is formed as a result of the lack of formal crossings between the station to the new developments on the east side of York Way (see Plate 4.10). Crossing is made difficult by the large number of taxis, buses, cars and lorries present around King's Cross Station. High traffic speeds and lane changing movements reduce the space ownership of pedestrians. Buses parked on the west side of York Way, as well as cars parked on the east side reduce sightlines.

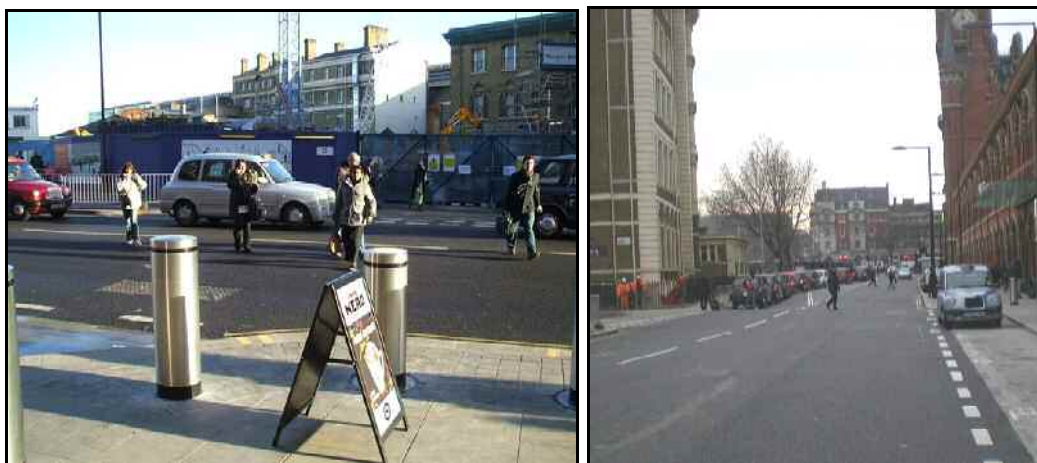
Plate 4.11: Informal crossing (C34) outside St. Pancras Station main exit

confronted with heavy and speedy traffic along Pancras Road. Dropped kerbs are provided on both sides of the crossing but are not aligned.

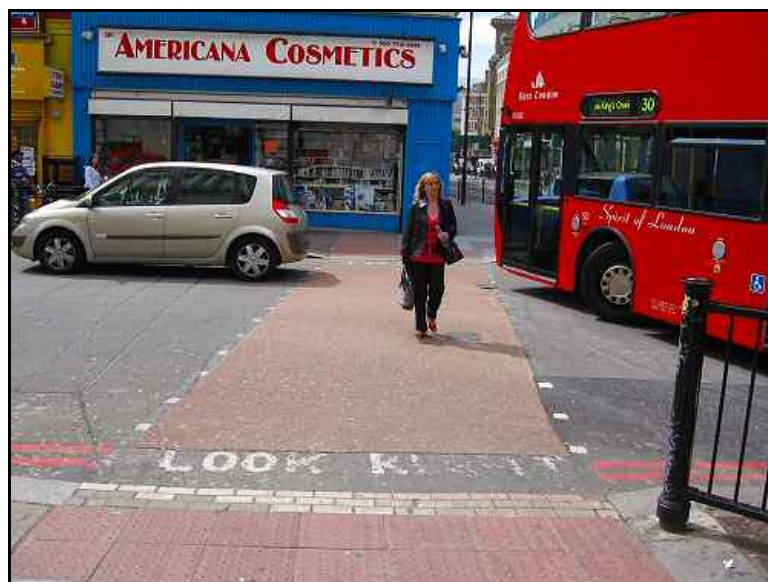
Plate 4.12: Lack of controls at crossing C18 across King's Cross Bridge placing pedestrians in danger of turning traffic

- **C18** Across King's Cross Bridge at junction with Pentonville Rd (southside) – Despite this being a controlled crossing, the lack of request boxes, short pedestrian green phase and excessive waiting time lead to many users crossing on red. As exemplified by Plate 4.12, such users are placed under danger by the heavy traffic, most notably buses turning left onto King's Cross Bridge. Safety for sensory impaired users is severely limited by the lack of rotating cones and audible information.

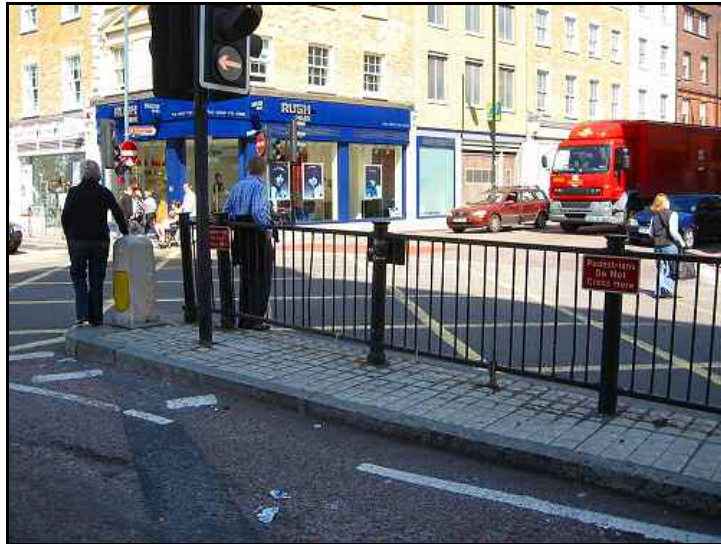
Plate 4.13: Dangerous informal crossing C19 across Pentonville Road

remains unserved. The alternative of navigating across the remaining three arms of this junction is unattractive to the majority of users. The central refuge is not suitable as a waiting area, and users are placed under great hazard from the heavy traffic.

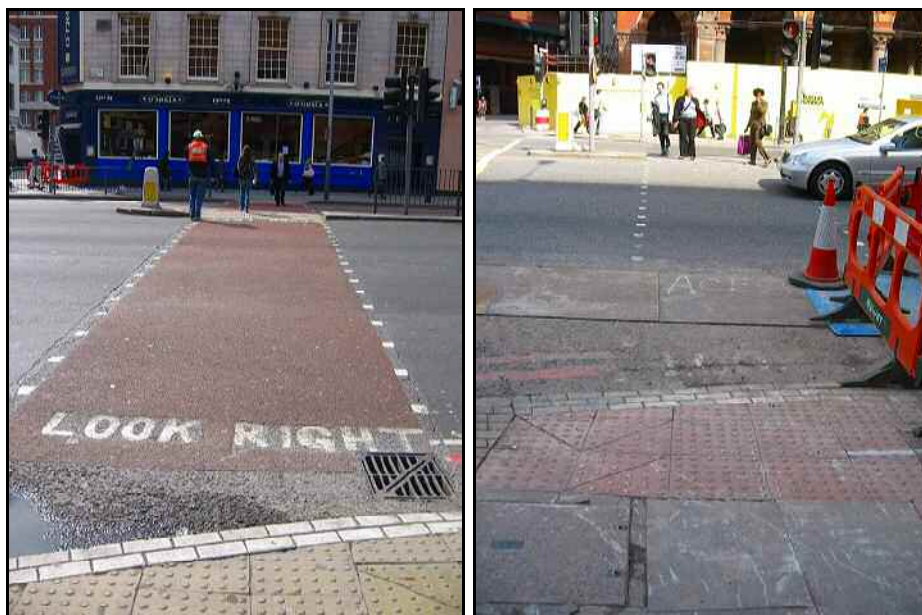
Plate 4.14: Inadequate crossing provision across Euston Road (C3 left, and C4 right)

- **C2/C3/C4/C7** Crossings across Euston Rd – The major crossing points across the heavily trafficked Euston Road (as pictured in Plate 4.14 below) are a major source of concern. On C3, the pedestrian aspect is missing. C4 suffers from inadequate refuge capacity, leaving pedestrians exposed to the speedy traffic. Delay is a major concern at all crossing points, due to the long wait times (often reaching 60 seconds) and the lack of synchronisation of the multiple stages. Cyclists often encroach on the crossing space due to the lack of advanced stop lines.

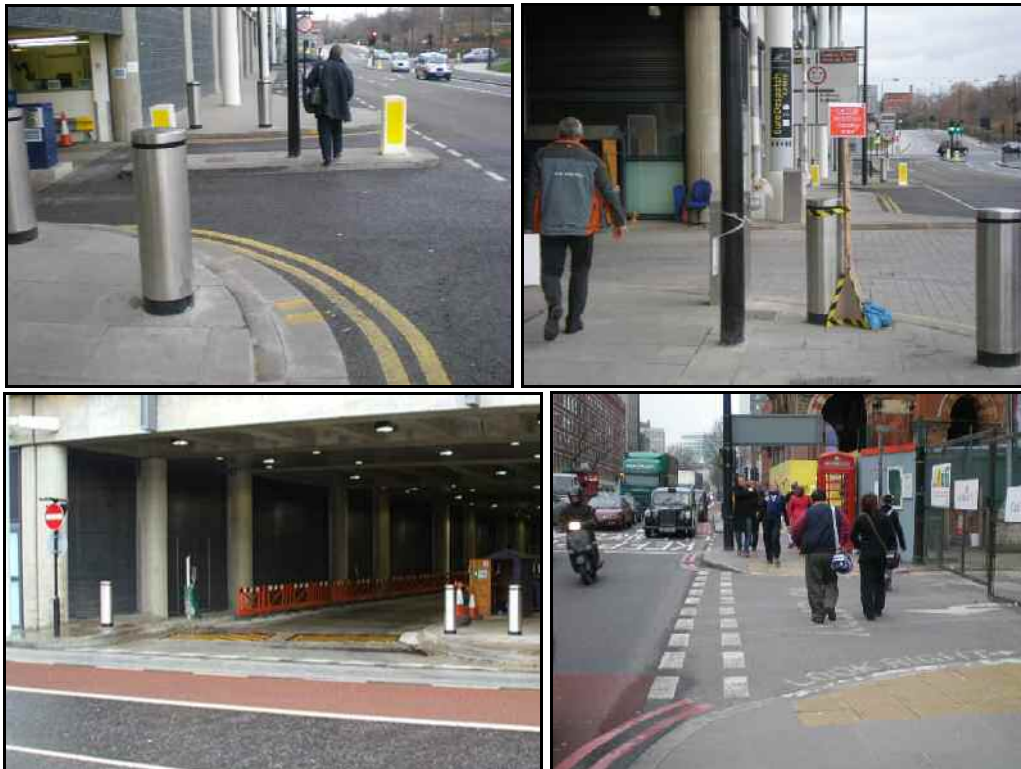
Plate 4.15: Lack of dropped kerbs and presence of obstacles across vehicle access roads to St. Pancras Station (C39 top left, C40 top right, C48 lower left, C6 lower right)

- **C39/C40/C48/C6** Across vehicle access roads to St. Pancras Station Building – There are several vehicle access points into St. Pancras Station (as shown in Plate 4.15 below), including the car park entrance (C40) and delivery gates (C40/C48). These often come without dropped kerbs; instead the height of the kerbs is found to be excessive. Combined with the presence of bollards on the approach path, access by wheelchair users is made very difficult. C6 currently performs well due to the lack of traffic, but when the hotel inside the St. Pancras Station building opens a constant flow of taxis and other vehicles is expected across the footway.

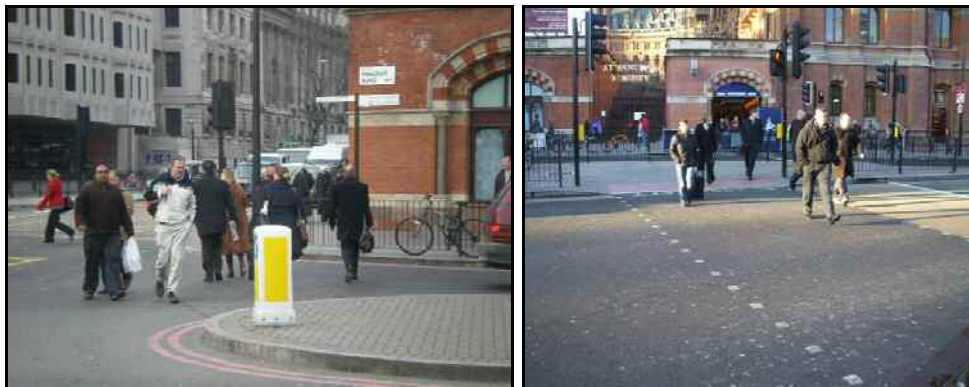
Plate 4.17: Desire line not being met at crossing across Pancras Road at junction with Euston Road (C8)

- C8** Across Pancras Rd at junction with Euston Rd (northside) – This crossing is strategically located between the entrances to both stations; hence it is used heavily by many travellers transferring between the two. Deviations are caused by the pedestrian fencing on both approaches and on the central refuge, together with the poor alignment of the crossing area. Many pedestrians therefore prefer to cross on the desire line at the mouth of the junction (as shown in Plate 4.17 below). Large delays are created by the lack of synchronisation of the two stages, excessive waiting time and short green phase (approximately 6 seconds) for pedestrians.

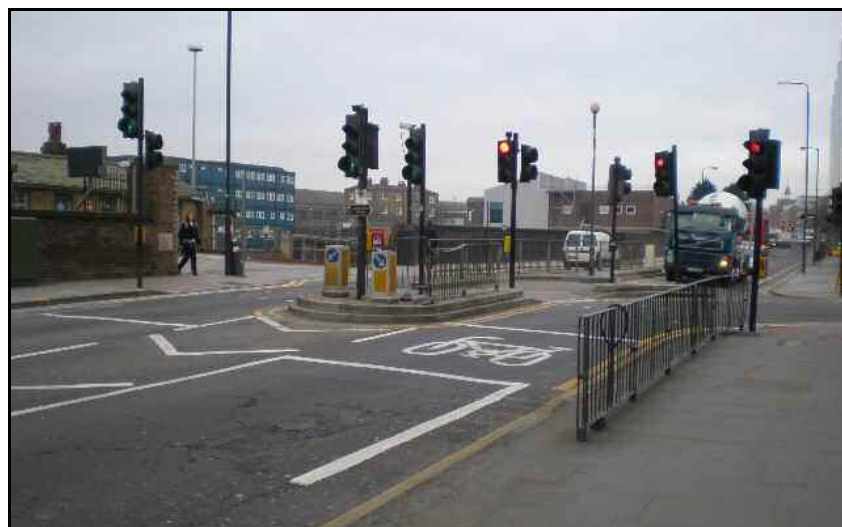
Plate 4.19: Poor alignment of crossing arms at C52

- **C52** Across York Way at junction with Wharfdale Road – This is a complex set of crossings with three arms branching out of a central refuge, found outside the northern entrance to King's Cross Station on the west side of York Way. Deviations are created by the use of the shared refuge for all directions, aggravated by the poor alignment of the arms (see Plate 4.19 below). Pedestrians wishing to travel across York Way must perform a Z-shaped movement, adding to delay. The new developments to the north of Wharfdale Road (e.g. The Guardian office) may create further demand for this crossing in the future.

The northern entrance to King's Cross is widely used by local people. Community street auditors were extremely concerned this could be closed off to pedestrians during redevelopment of the station; they observed it was regularly used by people on foot which implied need for entrance at this point. Local people felt it was vital to retain this northern access to the station. If closed, alternative access would be via Goods Way or York Way which were felt to be dangerous, especially at night.

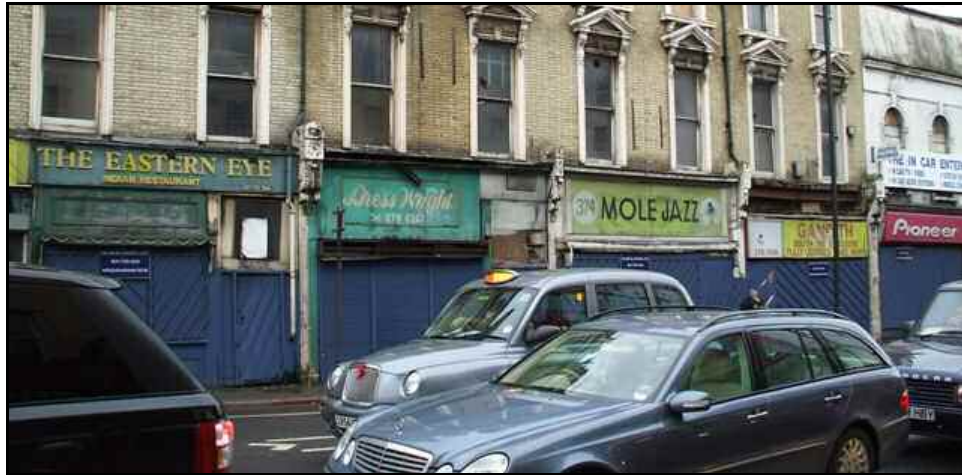
Plate 4.21: Closed shops and heavy traffic leading to poor environmental quality along R3/R4

Environmental quality is low due to noise and air pollution from Euston Road. The private frontages of low quality shops and fast food outlets are poorly maintained, and some are vacant (see Plate 4.21). There is evidence of anti-social behaviour and the lack of footway focussed lighting is likely to make this area intimidating at night. Surface quality is also a problem due to undulating and cracked pavements, especially around street trees. Tactile paving is also incorrectly coloured at some crossing points. There are no specific rest points other than at a bus stop near the Dental Hospital, raising concern for mobility impaired users or those with heavy luggage.

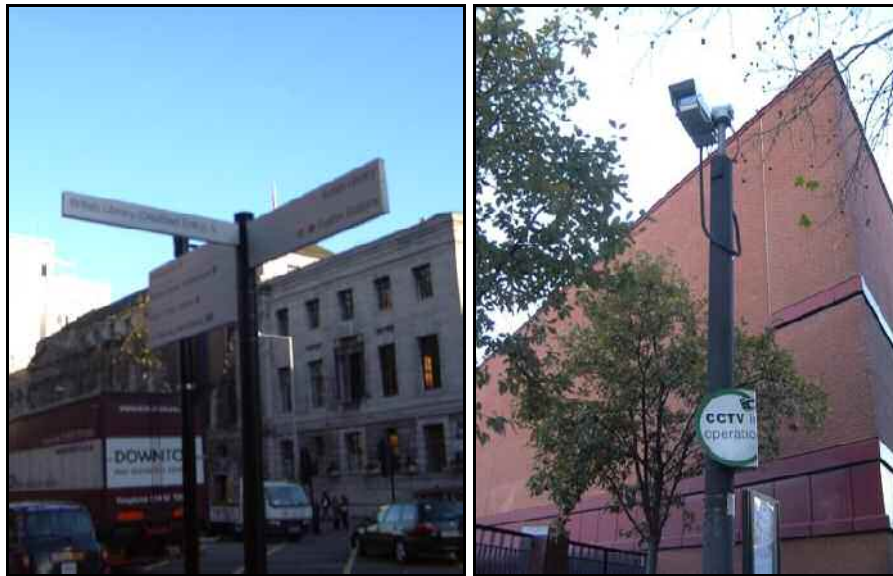
Plate 4.23: Good signage and CCTV coverage outside the British Library

- **R2** From St. Pancras Station (western entrance) along Midland Road to the British Library – This route scored well in both audits due to its directness, improved legibility (see Plate 4.23) and relatively high road safety. Wide footways and formal crossing provision outside the St. Pancras Station western exit allow good access to the library. However, the CSA audit highlighted the threat to pedestrians caused by the relatively high traffic speeds along Midland Road. This results from the lack of vehicle speed controls and the wide, straight, one-way format of Midland Road. The absence of soft landscaping to the frontages opposite the station and the lack of activity at the public space in front of the library creates a slightly isolated environment for pedestrians, although CCTV is present to increase personal security (as pictured in Plate 4.23). As with many routes and links in the area, there are many examples along Midland Rd and Euston Rd of redundant street furniture in the form of poles (related to the Eurostar terminal construction) that now simply need to be removed.

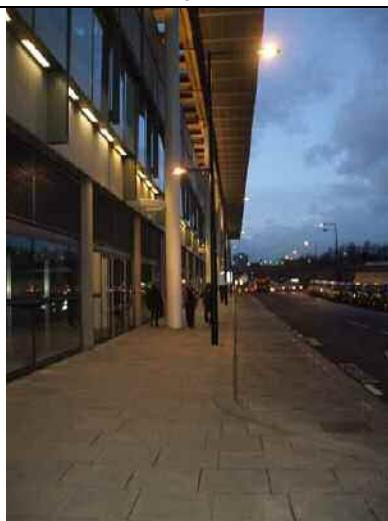
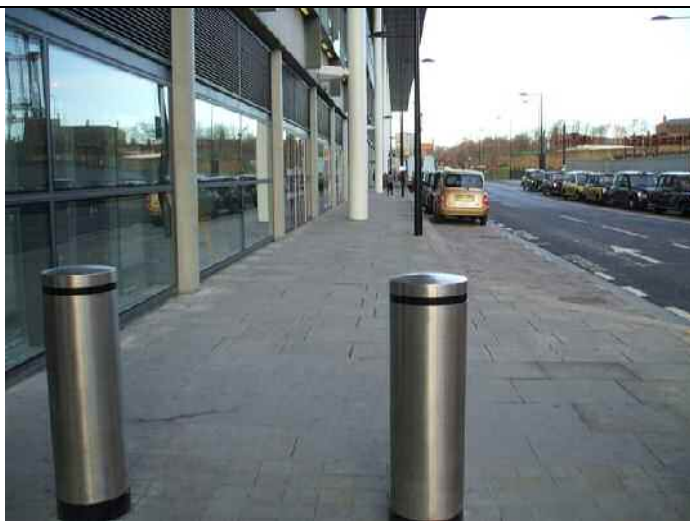
Pancras Road (eastside) from Euston Road to Old Pancras Road (L23)	
PERS Audit	CSA Audit
<p>This is a well used link by commuting pedestrians. At present the width is suitable for pedestrian flows. There are no obstructions on the northern end of the link but the southern end has tapering trees, bicycles locked to railings, sign posts and lighting columns. Congestion is limited, and flows are expected to be further reduced once the subway between the two stations becomes operational. There is no footway available between the taxi rank and Euston Road.</p> <p>There is one formal crossing at the northern end of the link but the southern end is inaccessible due to lack of footway. Queuing taxis, the taxi rank and pedestrian barriers add to the poor permeability, together with the lack of dropped kerbs. There is a clear crossing, with tactile paving present to one major entrance to St. Pancras Station (across St. Pancras Road) and yet there are no dropped kerbs at this location.</p> <p>The area may feel isolated at night when the station closes. The northern end of the link has 'piggy back' lighting, whereas lighting to the southern end is carriageway focussed with small footway focussed spot lights.</p> <p>Levels of maintenance are mixed. The northern end is smarter with a newly laid footway, whereas the southern area is more run down with dirty frontages/railings and litter on the edge of the link. Here, depressions, cracks and puddles have formed especially where there are reinstatements and tree roots.</p>	<p>Very poor. Clearly at present the other side of the street where there has been little investment compared to footways on the western side. The link passes the chaos of the redevelopment of King's Cross, the chaos other taxi rank and ends at the chaos of yet another. building site. In the longer term it is hoped that the aim is to create a pedestrian environment that is attractive as the western side of the road.</p>

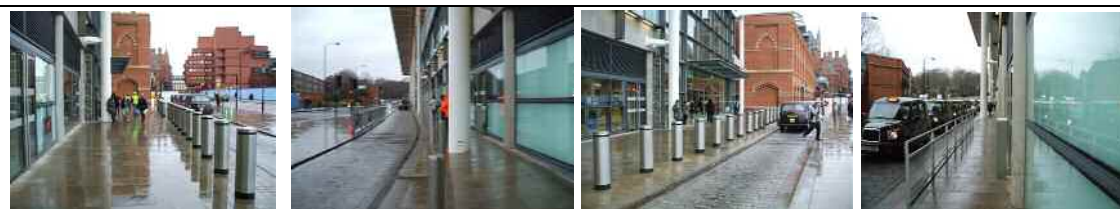
Euston Road (southside) from Crestfield Street to Argyll Road (L10)	
PERS Audit	CSA Audit
<p>The underground entrance reduces the width of the link and reduces sightlines which is most likely to be problematic during peak periods but generally the effective width of the link is adequate. A-frames and posts are generally aligned. Posts and guard railings are also contrasted.</p> <p>Heavy traffic and guard railing reduce pedestrians' crossing options. There are also few dropped kerbs across Euston Road.</p> <p>Navigation is aided by the sight of major landmarks, pedestrian signage, new fingerposts and street names. St. Pancras Station gives a good sense of place, but noise levels are high and air quality feels poor.</p> <p>There are warnings on the link about street crime, but there is CCTV present and street activity is high which aids perceptions of safety. There are a mixture of lighting types, with some focussed solely on the footway.</p> <p>Environmental quality is aided by adequate maintenance, although the link may suffer from dropped leaves during autumn months and surface quality can be poor. For example, sunken utility covers create trip hazards and there is also uneven paving at the crossing across Argyle Street.</p>	<p>There are lots of A boards here. There are 3 different types of pedestrian signage - none with distance or time on. The pavement is narrowed by the entrance to subway, but is busy with people on foot. There is a black pole with signage exacerbating the pinch point. Auditors felt the signage pole should be relocated nearer the kerb line.</p>

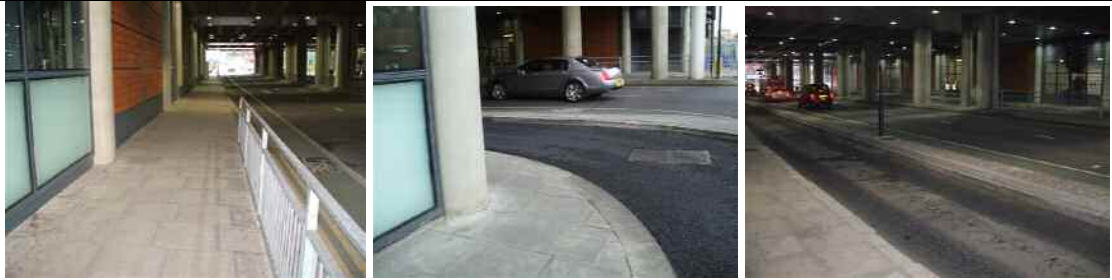
Goodway tunnel (northside) from Pancras Road to Midland Road (L26)	
PERS Audit	CSA Audit
<p>Width is acceptable throughout for very low pedestrian flows. The wide link allows for safety from vehicles and also allows for obstructions which are simply poorly aligned. A vehicle sign in the tunnel causes narrowing of width and a signpost on the west end is very poorly aligned, but the width of the footway allows for this.</p> <p>Pedestrians and cyclists are segregated due to the presence of a cycle lane. However cyclists were observed ignoring the lane separation entirely.</p> <p>There is no formal crossing along the whole length of the tunnel or at each end. Informal crossing is difficult owing to a central barrier, step to the carriageway and a high kerb. Tactile information is present at the formal crossings at each end of the link.</p> <p>There is better signage when approaching from the west, with a vehicle and pedestrian sign half way through. There is a finger post at the west end which is clear, but shows no distances.</p> <p>Although well lit, the tunnel would feel isolated and exposed at night due to lack of users and lack of surrounding activity. Once on the link there is no other route to exit and there are places for concealment at both ends. CCTV present on the opposite side of carriageway. The white light used is best practice.</p> <p>The walking environment is very loud owing to the tunnel acoustics, despite only low to moderate traffic flows.</p>	<p>Auditors felt that this link was well lit but otherwise an awful environment for pedestrians (see L25).</p>

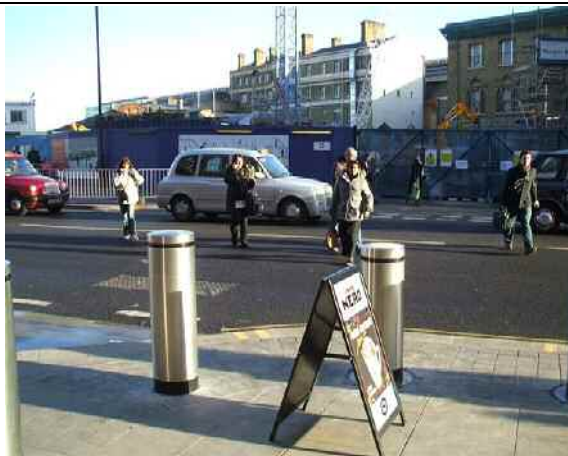
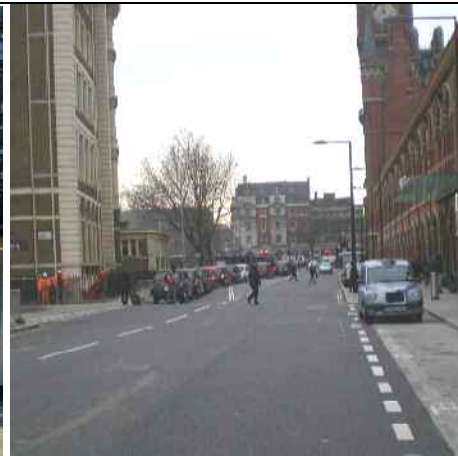
Across King's Cross Bridge at junction with Pentonville Rd (southside) (C18)	
PERS Audit	CSA Audit
<p>Provision is poor given the high vehicle flows and speeds and also high pedestrian flows. There are no pedestrian request boxes so pedestrians continuously cross informally at the formal crossing. Pedestrian barriers prevent any sort of deviation. There is no pedestrian priority.</p> <p>Sightlines when crossing from the north are blocked by waiting buses. Waiting areas are adequate but the crossing is highly unlikely to cope during the peak hours as so many pedestrians cross informally.</p> <p>High vehicle flows are present around the crossing, including many turning buses. The pedestrian phase is very short and has a long waiting time which leads to excessive numbers of pedestrians crossing informally.</p> <p>The crossing delineation is faded but red demarcation assists legibility. Tactile paving is correct and intact but there are no buttons, audible information or rotating cones.</p> <p>Dropped kerbs are generally well flush with white edges. Buses continually queue over the crossing point; this provides obstructions for pedestrians wanting to cross.</p> <p>Some utility covers are not flush and a pot hole is present in the carriageway.</p> <p>Generally the crossing is clean but there is a high degree of debris and discarded cigarette ends by the kerb edge.</p>	<p>This crossing is often blocked by bendy buses turning left. There is severe ponding at the drops when it is wet. There is a delay of 70 secs whilst waiting for green man whilst traffic flows along Pentonville Road. As with the whole of the area, this is a location that would particularly benefit from the review of the one way system and the creation of increased opportunities for pedestrian crossing on C19.</p>

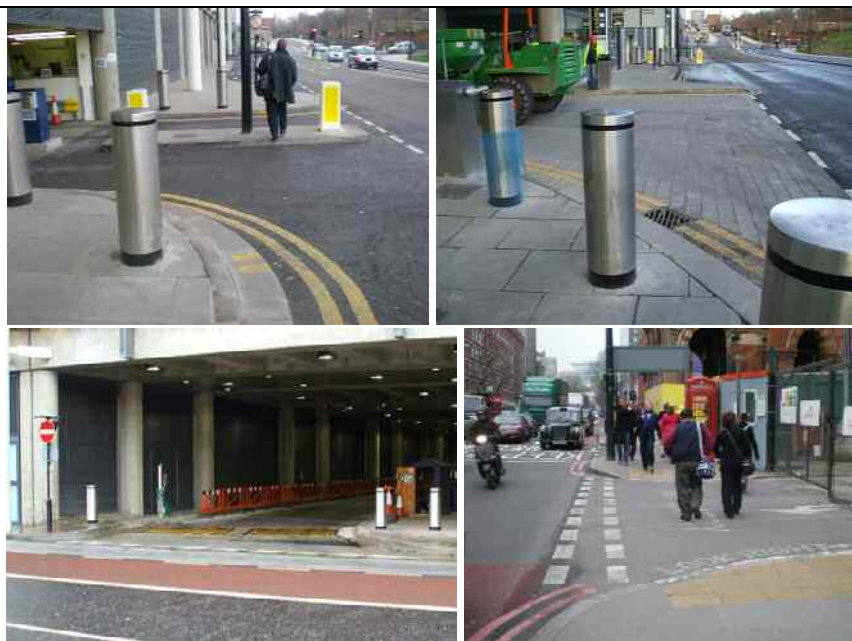
Across Midland Rd at junction with Euston Rd (northside) (C5)	
PERS Audit	CSA Audit
<p>This is a two-staged crossing across a moderately-trafficked road. A high number of pedestrians use the crossing, which suffers from under-capacity. Waiting area on the north side is narrow, and the refuge is particularly congested and hence not suitable for peak flows or for those on wheelchairs.</p> <p>A number of obstructions including bollards, CCTV cameras and temporary construction material are present.</p>	<p>There is no ASL for cyclists so they encroach and have a habit of blocking crossings. There is a green man with refuge. The refuge should be widened to allow greater capacity to wait safely in middle of road. All surfaces are well made and flush. Midland Road is one way, which is quite convenient for crossing. The delay is short and the crossing time long. An ASL should be created and the refuge should be widened.</p>

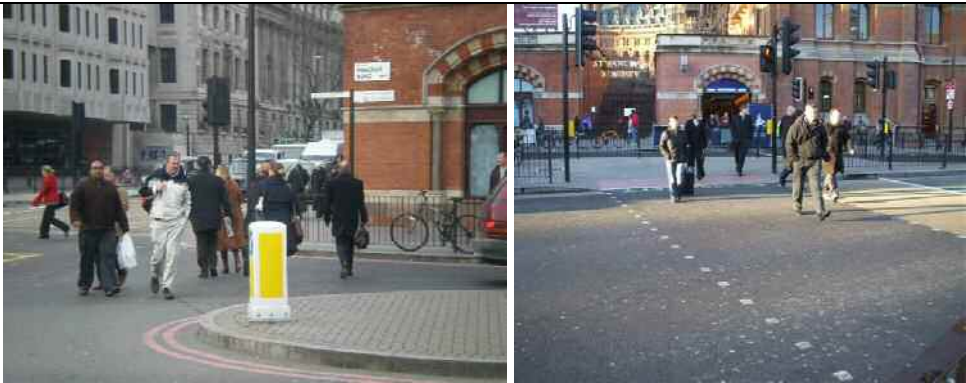
Across York Way at junction with Pentonville Rd/Euston Rd (northside) (C9 and C10)	
PERS Audit	CSA Audit
<p>C9 A pelican crossing across a moderately busy road. Barriers are present at either side of the crossing but do not cause excessive deviation. Vehicles are seen to queue over the crossing space. Delineation is heavily worn and the crossing is no longer clear. Surfaces are also poor on the carriageway. The refuge in the centre of the junction is heavily congested throughout the day as it serves 3 crossings. The request button is heavily worn, with no audible information nor rotating cones provided. Good tactile is provided at the refuge but is heavily interrupted on the east side.</p> <p>C10 Pedestrian flows vary on this crossing. When tours or groups of children cross, the refuge becomes heavily congested and capacity exceeded. Width is suitable for wheelchairs, but they may struggle under crowded conditions. Neither audible information nor rotating cones are provided. Tactile is of correct colour and in place but the kerb edge is bricked. There is a sign post in the middle of the approach on the south side together with bollards and parked bicycles. A CCTV column, traffic lights and barriers obstruct on the north side (refuge). Sightlines are adequate.</p>	<p>C9 A very busy crossing point featuring a central island that is far too small for the numbers who use it and which has other crossings heading off in three directions. It is noticeable just how aggressive vehicles are at this point. Auditors felt that casualties were inevitable owing to the sheer numbers wanting to cross, the inadequate space for pedestrians and the desire of cars to move through the area as quickly as they could. The carriageway surface is uneven and the crossing itself is far too narrow. The central island should be removed to allow pedestrians to cross C9, C10 & C11 in one movement. The crossing needs to be widened and the delay for pedestrians reduced. Auditors felt that vehicles speeds must be reduced.</p> <p>C10 The crossing is too narrow, leading people onto a cluttered central island (containing 9 signs of different styles, 1 light column, 3 cameras mounted on 2 columns, 2 illuminated bollards, 4 traffic light columns and lots of railing) which is not big enough to cope with flows outside peak hours and is like a 'battle-ground' at rush hour. Consequently at all times of day people avoid the central island by walking around it. People motor vehicles turning off Euston Road up York Way do so at an intimidating speed, passing close by vast numbers of people waiting on the island or on the western pavement. The narrow opening between the guardrail on the western pavement forces people to bump and jostle past each other. The nearby kiosk adds to the claustrophobic feelings associated with this crossing at peak hours. There is a long wait for the green man. The central island should be removed and pedestrians should be able to cross C9, C10 & C11 in one movement.</p>

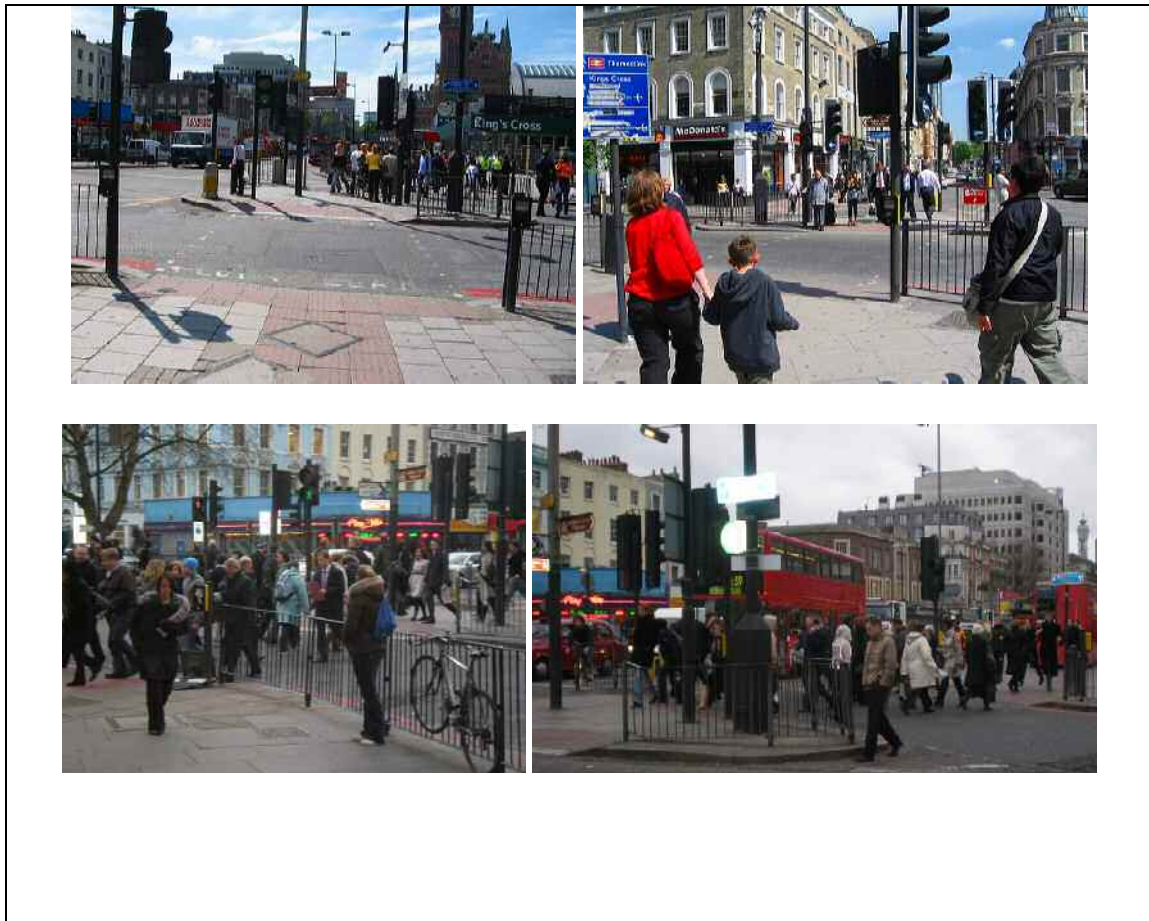
Across York Way at junction with Wharfedale Road (C52)	
PERS Audit	CSA Audit
<p>This is a 2 stage crossing requiring some deviation around barriers. The 2 stage nature of the crossing with the fast moving traffic creates some delay. Damage to pedestrian barriers need to be addressed.</p>	<p>This is a very poor crossing and its sheer over-engineering points to many of the problems in the area. At no point is direct crossing possible and pedestrians have to wait on the island in middle of road. The damage that has been caused to the crossing and its guard rail point to the high vehicle speeds and heavy vehicles movements in the area. Auditors felt that the crossing should be redesigned to allow pedestrians to cross road in one go and vehicle speeds should be lowered to reduce the threat to pedestrians at the crossing. Key here too is the proximity of the crossing to the northern entrance to King's Cross which is widely used by local people. Auditors were extremely concerned this could be closed off to pedestrians during redevelopment of the station; they observed it was regularly used by people on foot which implied need for entrance at this point. Local people felt it was vital to retain this northern access to the station. If closed, alternative access would be via Goods Way which felt to be dangerous, especially at night.</p>

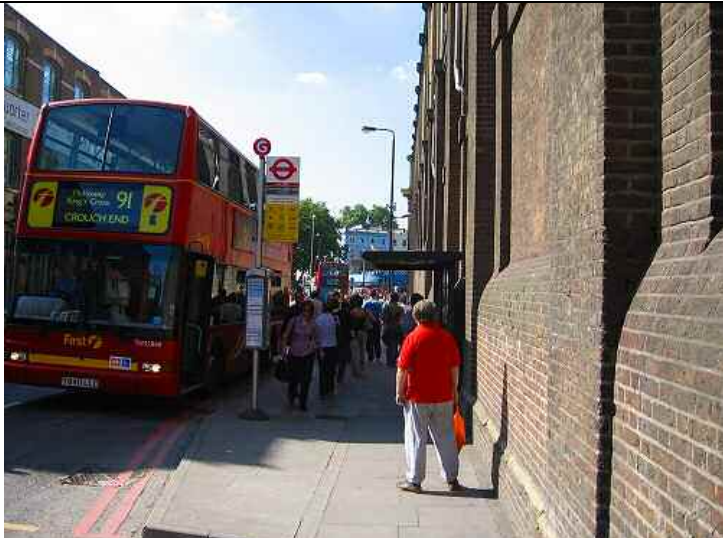
Bus Stop eastside of Caledonian Rd south of Caledonia St (PT8)	
PERS Audit	CSA Audit
<p>The main problem with the waiting area is the poor environmental quality of the stop and surrounding area, which makes it unwelcoming for waiting pedestrians and also decreases users' perceptions of safety. Shop frontages are poor, there is no landscaping and noise levels are high. There is graffiti in a stairwell recess near to the stop, which could also be used as a place for concealment. Lighting is present but offers illumination to the carriageway only. There is a light to the shelter. Maintenance also appears insufficient; there is a lot of dust around the waiting area and surfaces are not clean.</p> <p>There is also a problem with access to the waiting area. Crossings are some distance away from the waiting area, which encourages informal crossing of a busy road. Additionally, at the formal crossings there is minimal tactile paving. The waiting area is quite narrow, and in particular wheelchair users are likely to struggle to get past waiting pedestrians.</p>	<p>As with many bus stops in the area there is little space for those waiting for the bus and pedestrians using the pavement. Space needs to be re-allocated from vehicles to the large numbers of pedestrians in the area.</p>

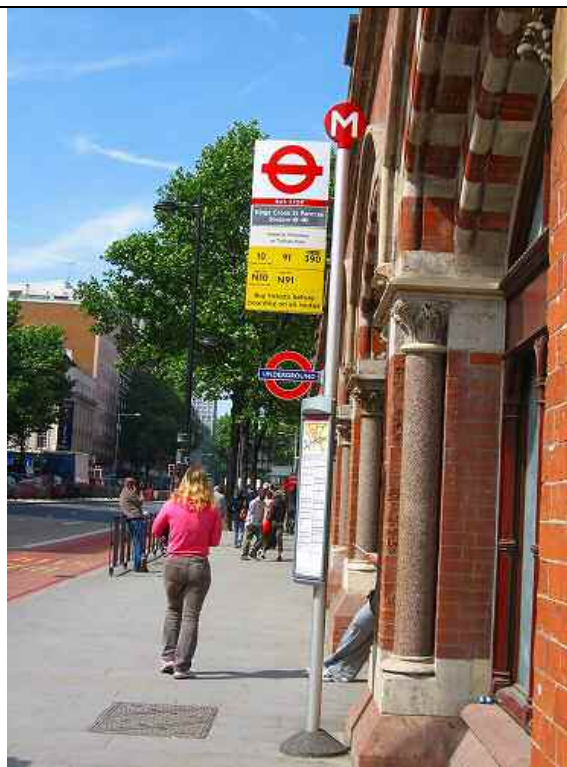
Bus Stop A outside Camden Town Hall southside of Euston Rd (PT6)	
PERS Audit	CSA Audit
<p>There is no opportunity for pedestrians to cross informally at the waiting area as central barriers prevent crossing. This results in deviations to access formal crossings of approximately 30m in either direction of the waiting area.</p> <p>Kerbs at the waiting area are not suitably raised, and pedestrian conflict on the footway results from waiting pedestrians. Other infrastructure problems include a lack of footway focussed lighting, where the closest lighting to the stop is obscured by a tree.</p> <p>There is both seating and a shelter present.</p> <p>The waiting area is clearly visible but there is no local information or additional information provided. Timetables are present, and there is only minor graffiti to infrastructure. The stop is clean owing to street sweepers and cleansing workers. However, a litter bin has not been provided. Environmental quality is somewhat decreased by very high noise levels; however this is partially offset by the excellent sense of place that St. Pancras Station offers, as well as the presence of soft landscaping.</p>	<p>Bus stop W creates a pinch point and has a solid end panel. The solid end panel should be removed to reduce pinch point.</p>
