Transport for London

Category A Station Audits

King's Cross and St. Pancras Stations

Final Report

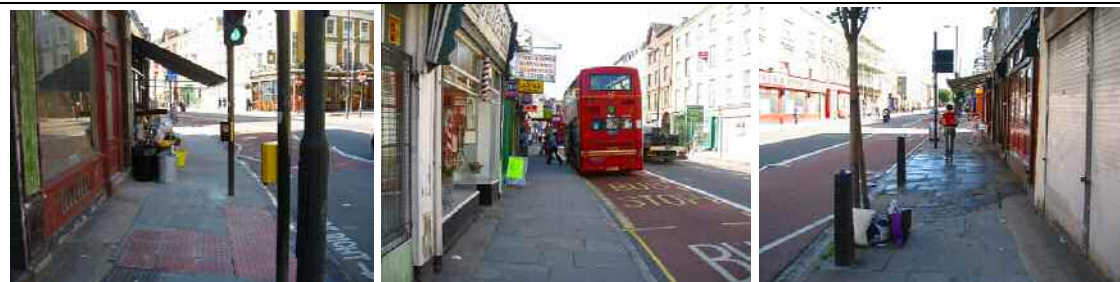
Pentonville Road (northside) from York Way to Caledonian Road (L5)	
PERS Audit	CSA Audit
<p>Pedestrian flows on the link are relatively high, and the width of the footway does not always accommodate the pedestrian flows entirely although standards are met. Several obstructions cause pinch points, such as A boards being located in close proximity to permanent street furniture.</p> <p>Surface undulations are present, but as a whole the footway is generally level. Dropped kerbs are provided at crossing points, although not all are sufficiently flush to the carriageway. The crossing points are located at either end of the (short) link, but otherwise kerbs are high and may limit informal crossings. Tactile information is present at crossing points, although there are interruptions at Caledonian Road. Pedestrians with sensory impairments could potentially use the adjacent buildings as a tapping line, although A boards frequently interrupt. Very poor quality reinstatements affect the level of tonal contrast on the footway. Generally link surfaces are variable, with some areas of particularly poor quality surfacing.</p> <p>In terms of legibility, there is a signage board with a detailed map, and fingerposts on the link appear newly installed. Street activity on the link aid perceptions of personal security, and CCTV is present. Lighting is carriageway focussed and footway illumination after dark would rely on lighting from frontages. Frontages are of fair quality and maintenance, although on the opposite side of the carriageway frontages appear to be of poorer quality. Environmental quality is decreased by discarded litter, cigarette ends and chewing gum. High traffic noise also degrades environmental quality.</p>	<p>A quirk in the kerb line at the junction of York Way means that approximately 1 metre+ of nearside carriageway is very under utilised by cyclists. Auditors noted that many cyclists appear to cycle in the main carriageway, partly due to positioning and to the quality of the surface of the cycle lane. There would appear to be an opportunity to increase pavement width, which is much needed along the length of this link. It is important to assess the apparent under utilisation of the cycle lane and consider widening the pavement. If the cycle lane is necessary reallocate road space to pavement. The Islington map (outside McDonalds) still shows King's Cross Thameslink Station. The footway is obstructed by A boards. There is severe ponding on the carriageway near the Pentonville Road entrance to Regents Quarter. Throughout there is a lack of bike parking. There is no east west link into King's Cross from Regent Quarter (off York Way). The Islington map needs to be updated, the A boards removed, cycle parking is needed and the ponding needs to be addressed.</p>

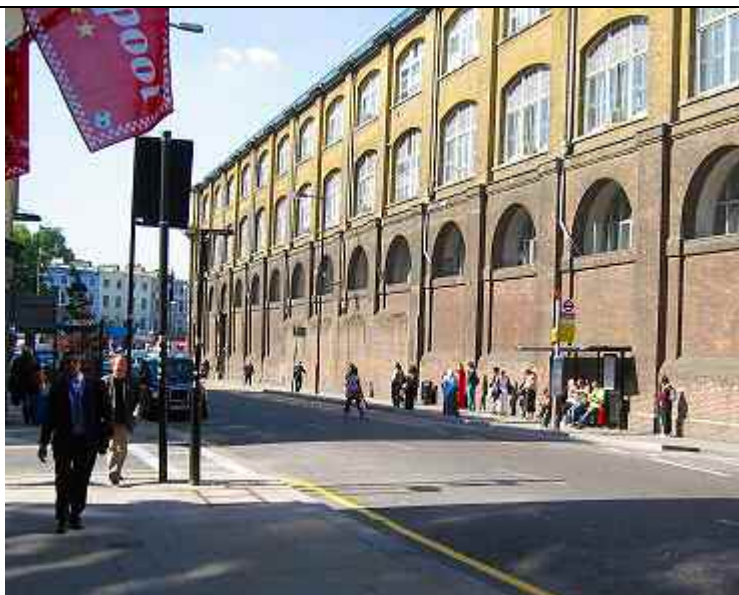
Informal across Pancras Rd from St. Pancras Station exit towards taxi stand (C34)**PERS Audit**

There is no crossing provided here despite there being a clear desire to go from the side exit of the station to the taxi stand and King's Cross Station. As an informal crossing, it lacks features such as dropped kerbs, measures to aid sensory impaired pedestrians. Heavy traffic flows make this a particularly risky crossing. Additionally metal security pillars obstruct the approach to the crossing, and sight lines are reduced by parked cars.

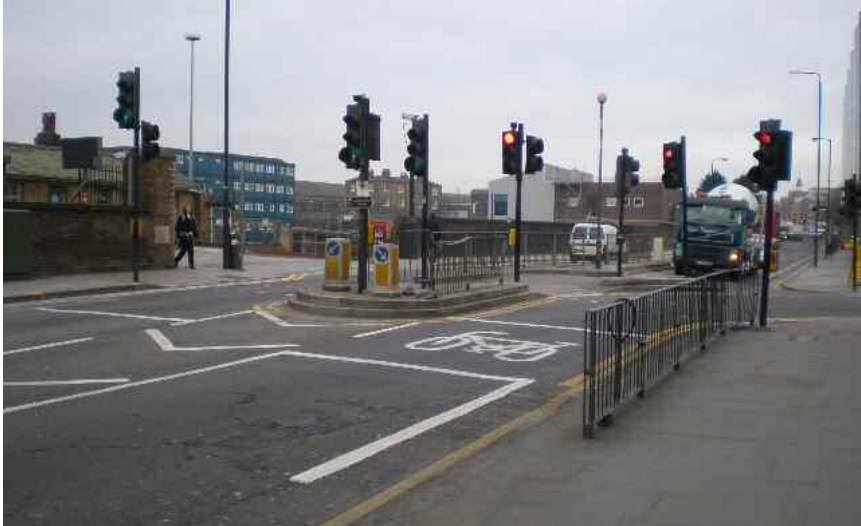
From St. Pancras Station along Gray's Inn Road to Eastman Dental Hospital (R3)	
PERS Audit	CSA Audit
<p>Deviations are minimal on this route. Crossing points are limited along the entire length of the route especially across the A5200, but a good Zebra crossing is provided opposite the dental hospital. All side roads are easy to cross. Barriers and very high traffic flow restrict movement on Euston Road. Sightlines are reduced by the bend in the road on Gray's Inn Road.</p> <p>Road safety is poor along Euston Road with very high vehicle flows. The environment is degraded and unattractive towards the southern end, with low quality shops and fast food outlets. Frontages are of poor quality and appear run down. Lighting is carriageway focused, leaving the footpath dark at night.</p> <p>Information to the hospital is limited to a map at St. Pancras Station. Tactile is provided at all formal crossings but incorrectly coloured grey at some side roads. Textured paving is provided around trees.</p> <p>No formal rest points are seen along the route, although some seating at bus stops and low walls provide informal rest points. The southern end of the route would not feel safe to rest especially at night. Some attempts have been made with soft landscaping but low branches and uplifting roots cause problems. Poor surface quality is observed at some locations.</p>	<p>It was widely agreed that this is an important route and that it is not very good due to crossing the Euston Road and the relative width of the pavement at particular hotspots, like bus stop R (see PT7). The route is utterly dominated by up to 4 lanes of one-way traffic.</p>

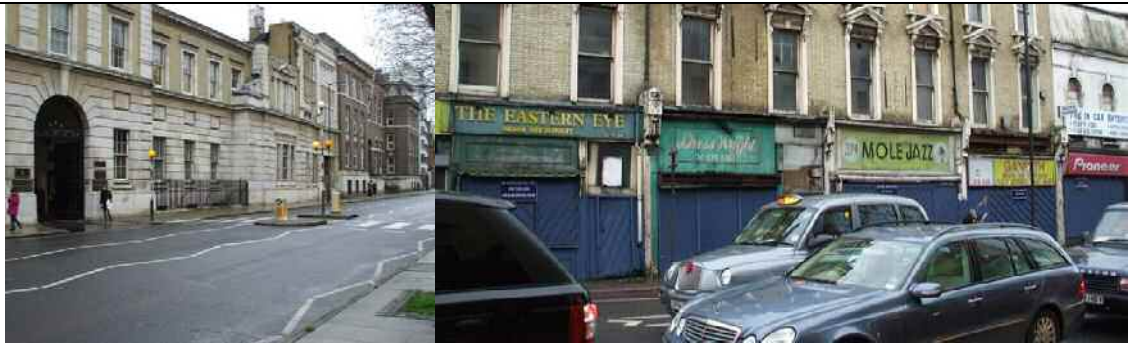
From St. Pancras Station along Gray's Inn Road to the Royal National Throat, Nose and Ear Hospital (R4)

PERS Audit	CSA Audit
<p>The route follows the same path with R3 for the most part. Formal crossing points exist along Euston Road, but are missing along Gray's Inn Road. Importantly there is no crossing outside of the Hospital. Moderate to high traffic flows are observed, especially on Euston Road. A lack of dropped kerbs is evident at several locations. Parked vehicles, carriageway curvature and footway obstructions significantly reduce sightlines on Euston Road.</p> <p>The environment is very intimidating even during the day due to lower quality frontages and a lack of maintenance. Many shops are closed or abandoned. There is some evidence of anti-social behaviour. Lighting is carriageway focused so the area is likely to feel quite dark at night.</p> <p>There is no signage to the Royal National TNE Hospital – the only information available is on the map at the station. It is therefore difficult to follow the route, especially since the areas around the station are very busy with pedestrians and high traffic volumes on large carriageways. Tactile is provided at most formal crossing points but is not necessarily correct.</p>

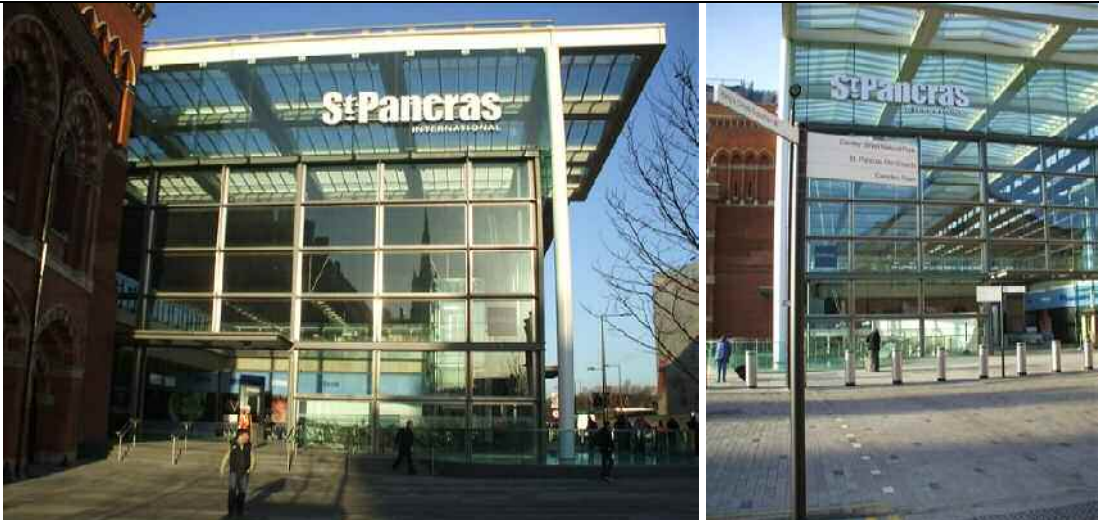
Between St. Pancras Station, Underground and Bus Stops A & M on Euston Rd (IS1)

PERS Audit	CSA Audit
<p>Crossings are provided for pedestrians at surface level as well as there being subways. Pedestrians do not have to cover large distances at the interchange space. Information is not present at all potential areas but there is no clear interchange space. In particular there is a lack of assistance or provision to aid disabled pedestrians.</p> <p>High street activity results in fair levels of user perception and CCTV is present at the subway entrance. One of the most significant problems is the lack of seating, which is only present at the subway entrance. The significant impact of the traffic is detrimental to the overall environmental quality.</p>	<p>This is very poor. As we have seen the bus stops on the northern side are located on extremely narrow pavements. On the south side the shelter causes a pinch point. Pavement widths on the northern side of Euston Rd are simply inadequate.</p>
